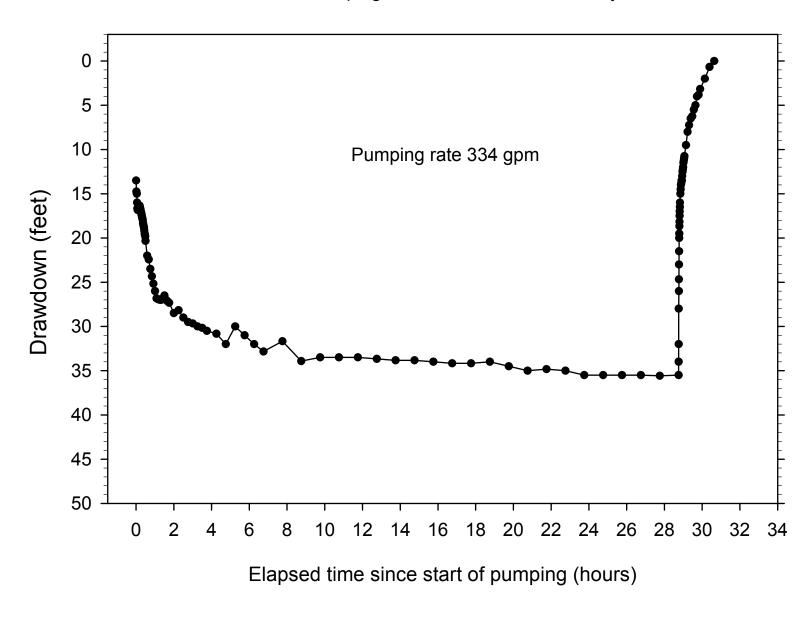
Figure 17 Drawdown and recovery data from pump-test at Y-61.
